Aspen Field Services

Job #:22485

2017 BOBCAT S650

Inspection Details	
Year	2017
Make	Bobcat
Model	S650
Serial Number	ALJ820299
Type	Wheel Loader
Inspection Date	6/18/2020
Location of Business	Bobcat of Toronto - 241 Deerhust Dr., Brampton, ON L6T 5K3
Attachment(s)/ Accessory(s)	Bucket Serial Number Not Visible
2-Speed	Yes
Enclosed Cab	Yes
Engine MFR	Doosan Infracore
Controls	Selectable Joystick Controls
High Flow Hydraulics - Sticker	No

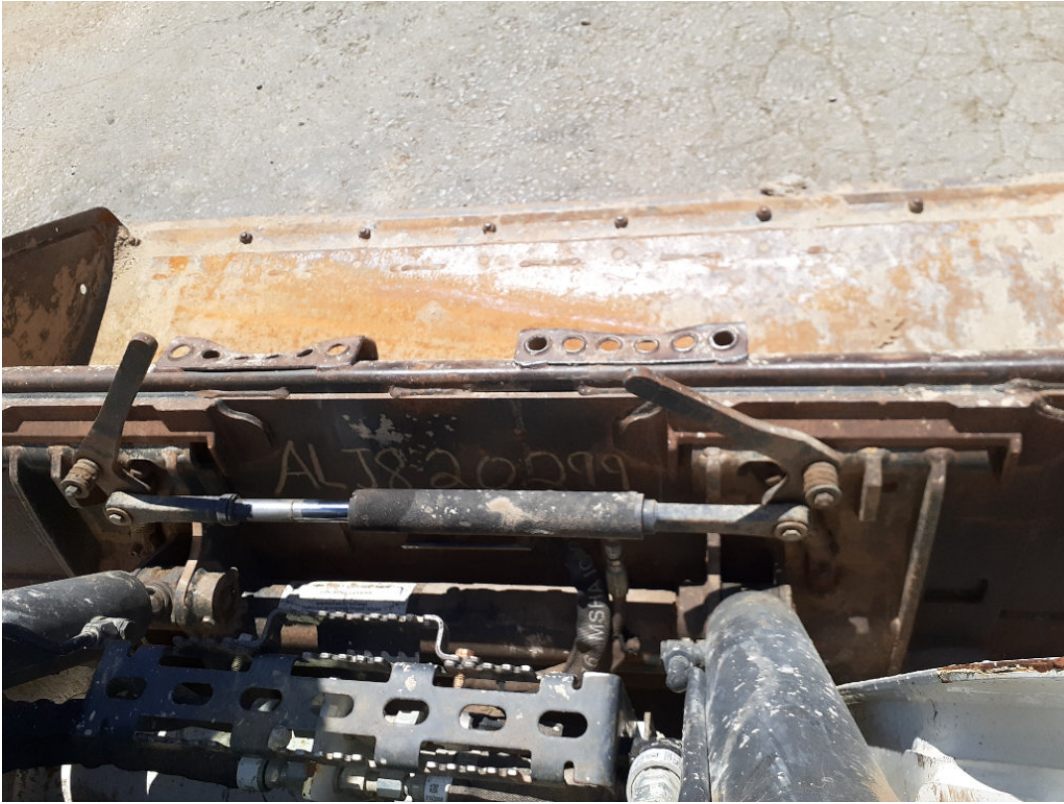
Not Visible / Attachment Serial Plate / 06-18-2020

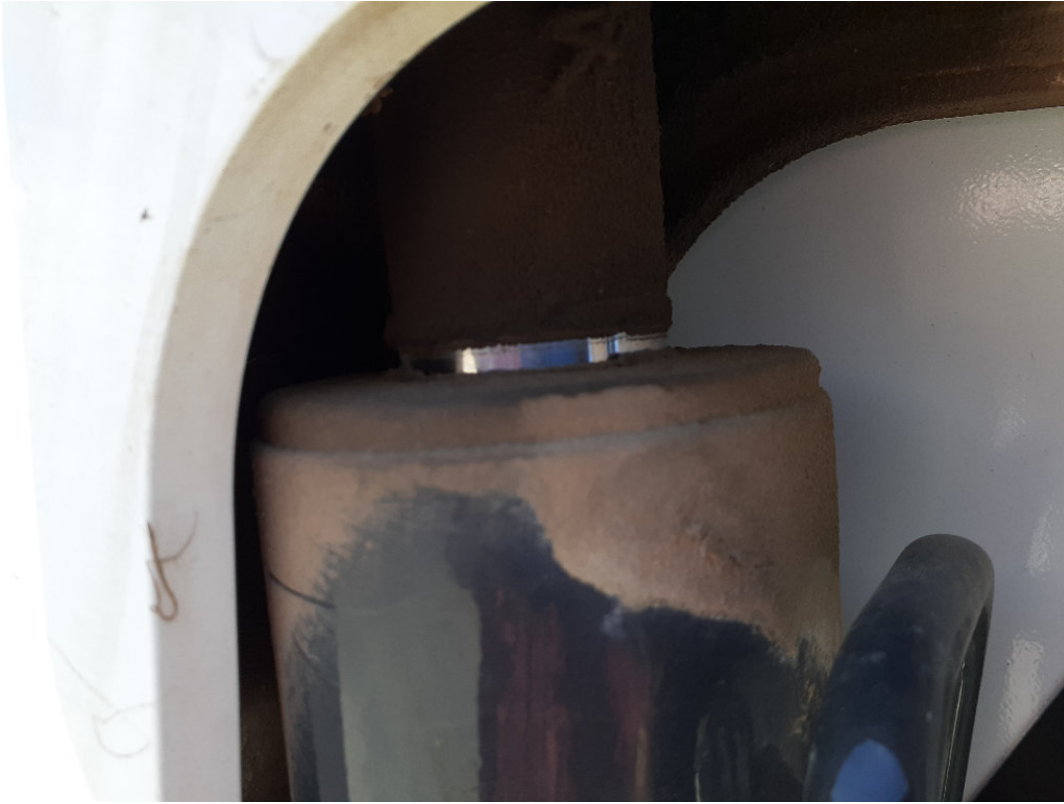
Left / Lift Cylinder / 06-18-2020

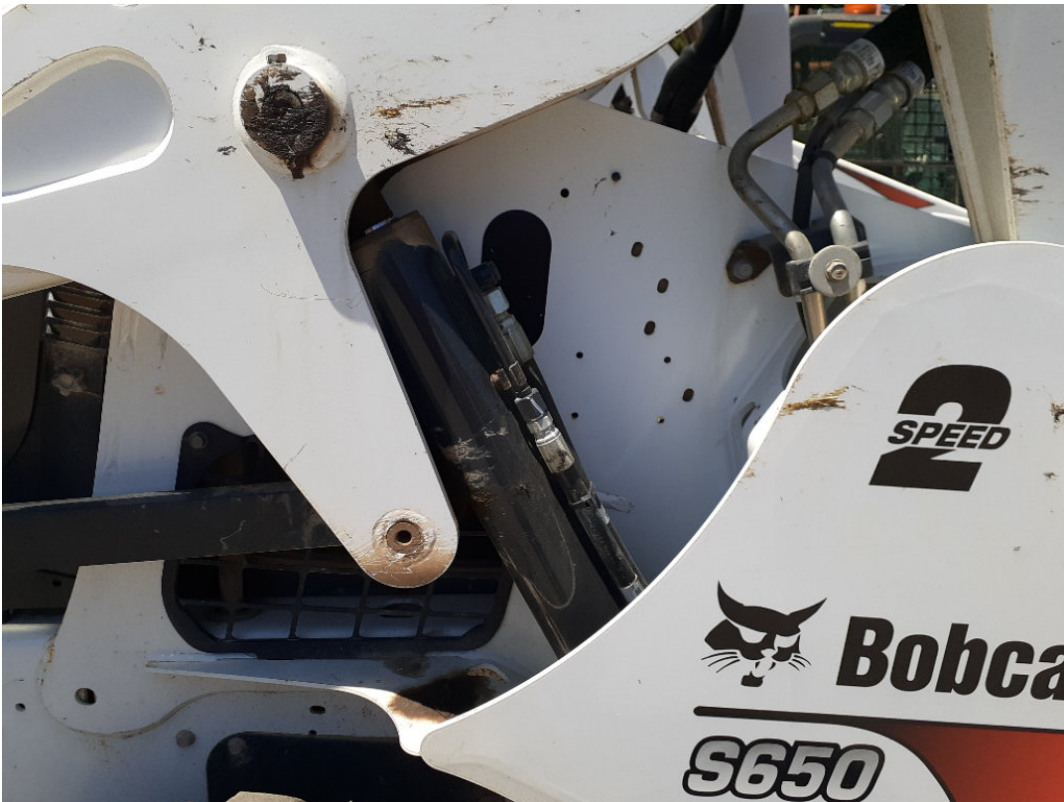
Left / Lift Cylinder / 06-18-2020

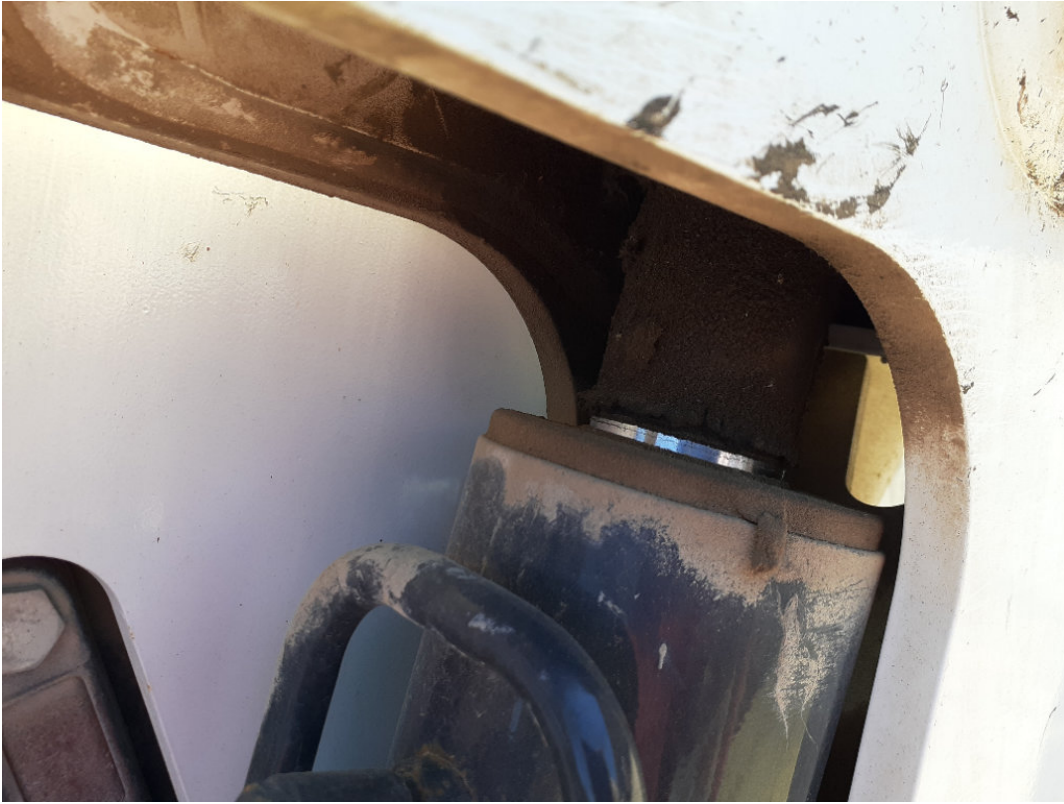
Right / Lift Cylinder / 06-18-2020

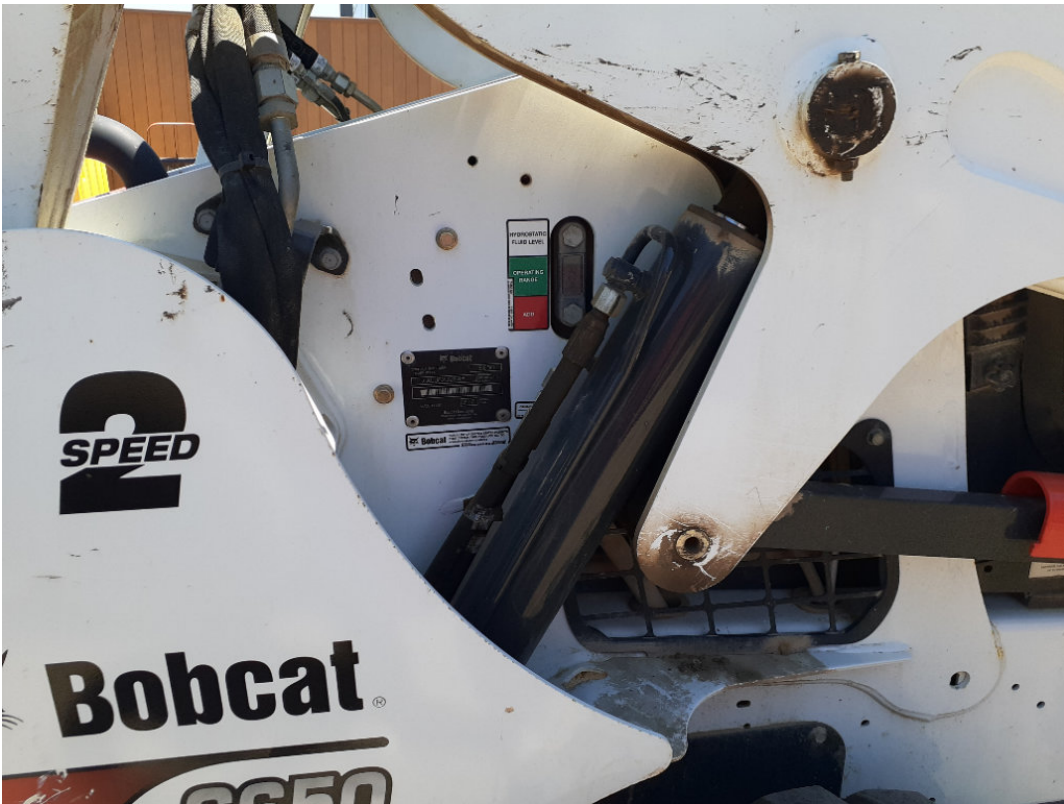
Right / Lift Cylinder / 06-18-2020

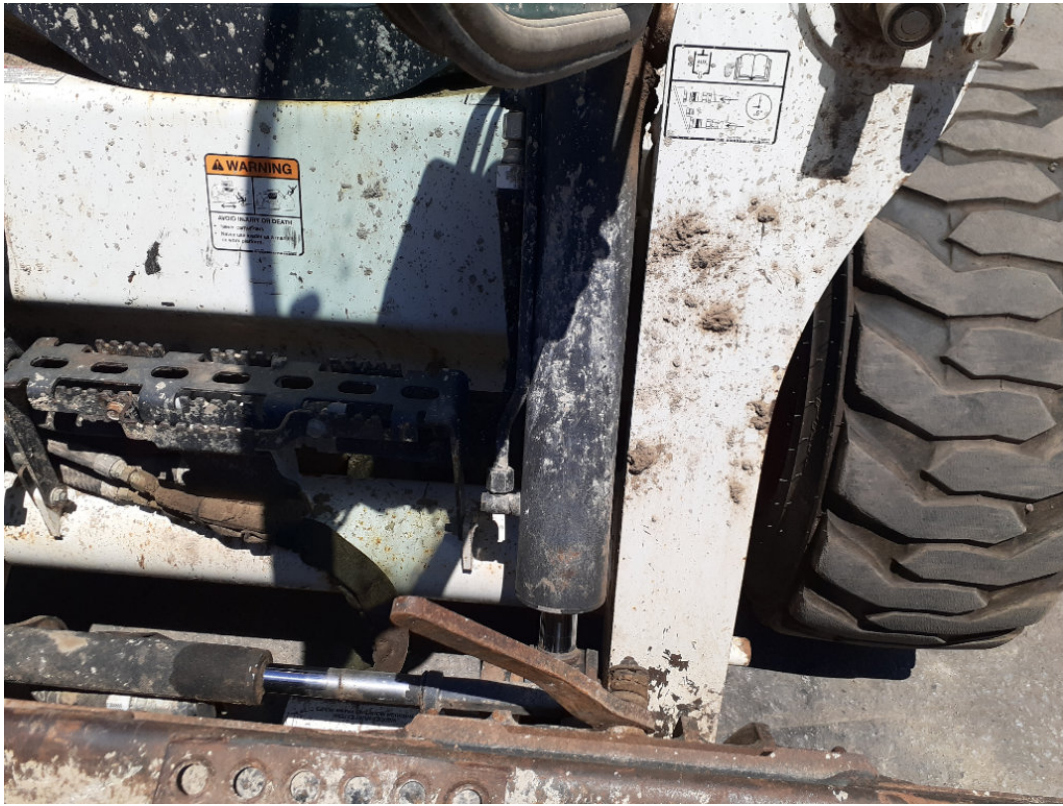
Left / Tilt Cylinder / 06-18-2020

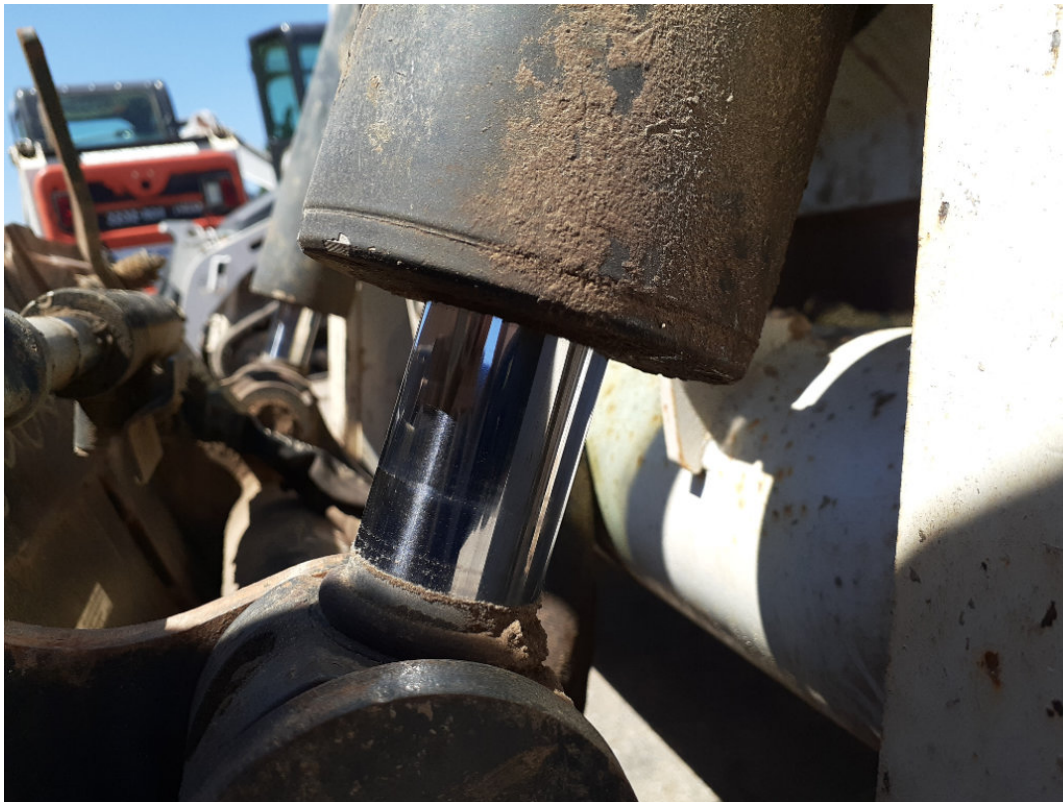
Left / Tilt Cylinder / 06-18-2020

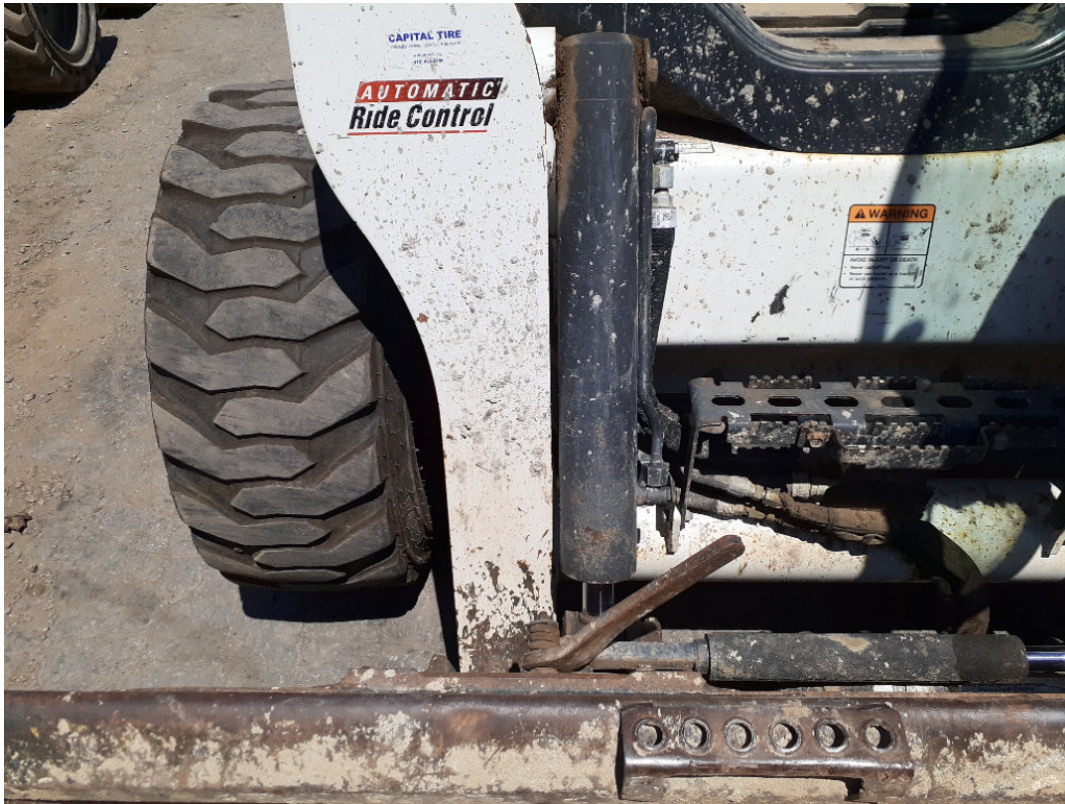
Right / Tilt Cylinder / 06-18-2020

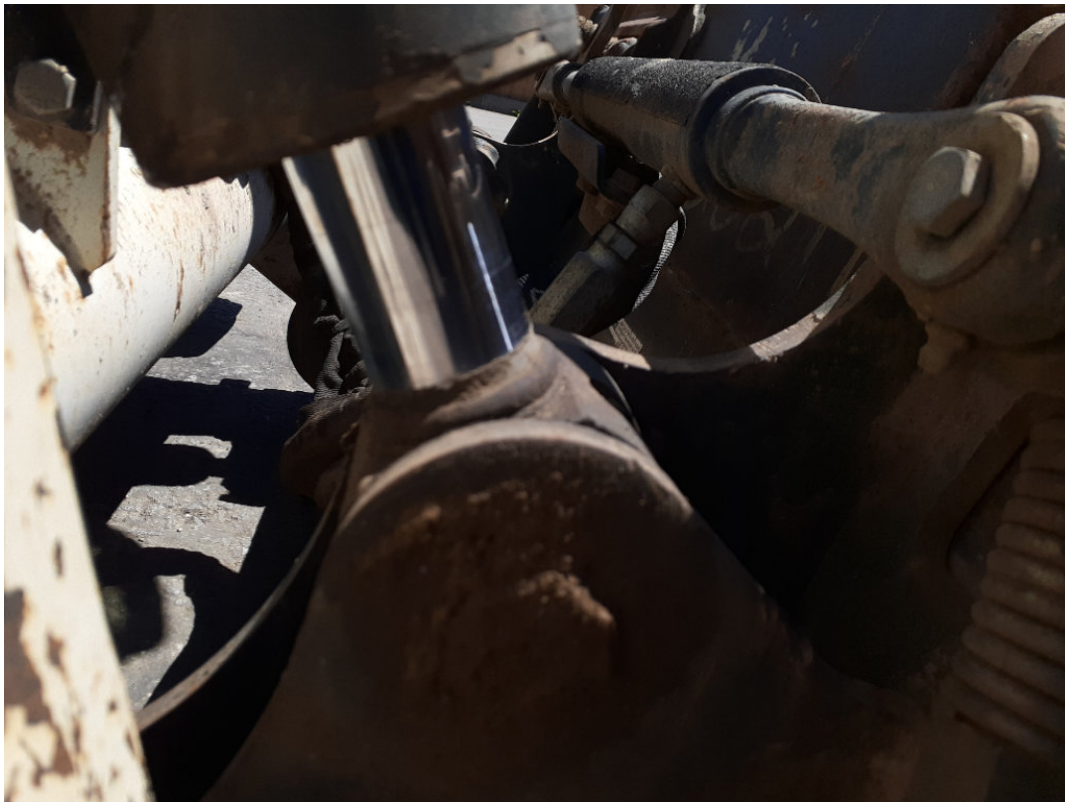
Right / Tilt Cylinder / 06-18-2020

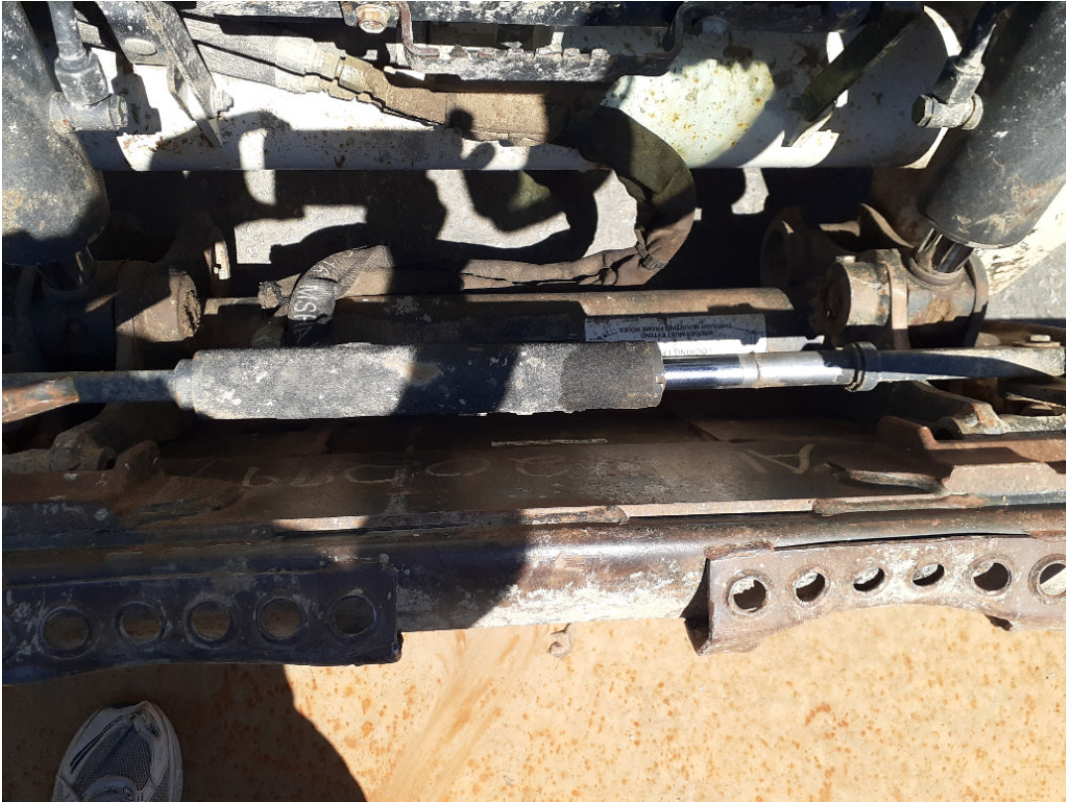
Power Bob-Tach Condition / 06-22-2020

Inspection Details Cont'd	
Right Track Depth Measurement	NA
Mismatched Tires	No
Mismatched Tracks	NA
Tilt Cylinders	No Leaks
Lift Cylinders	No Leaks
Boom Arms Operations	Working
Seat	Good Condition
Tailgate Lights	Good Condition
Working Lights	Good Condition
Front Door	No Damages
Side Glass Complete	No Damages
Rear and Top Window	No Damages
Boom Arms Damages	No Damages
Rear Door	Opens and closes and stays closed
Mufflers	Good Condition
ROPS Condition	Good Condition
Power Bob-Tach Condition	Non operational
Cab A-C Condition	Working
Cab Heat Condition	Working
Intake Screen	Good Condition
Interior	Good
Engine Compartment	Clean
Hydraulic X-Change Condition	NA
Customer Decals Visible on Unit	No
Comments	As seen in the video, the power bob-tach is unable to move into lock position.

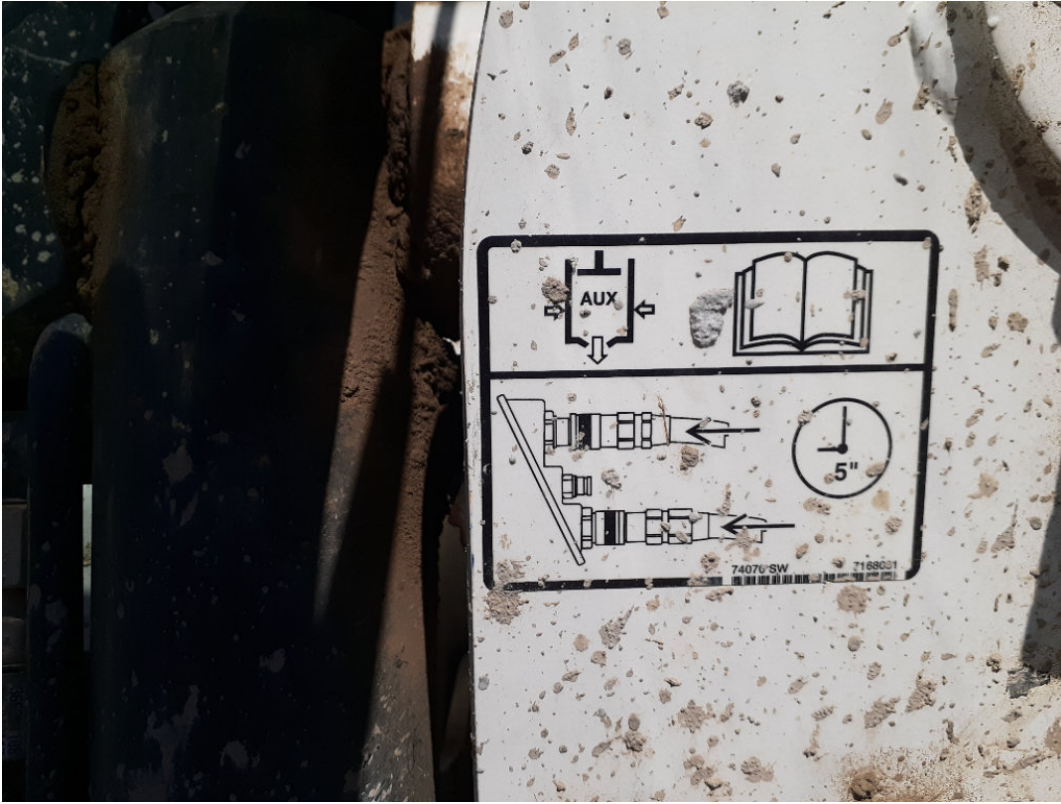
None / High Flow Hydraulics Sticker / 06-19-2020

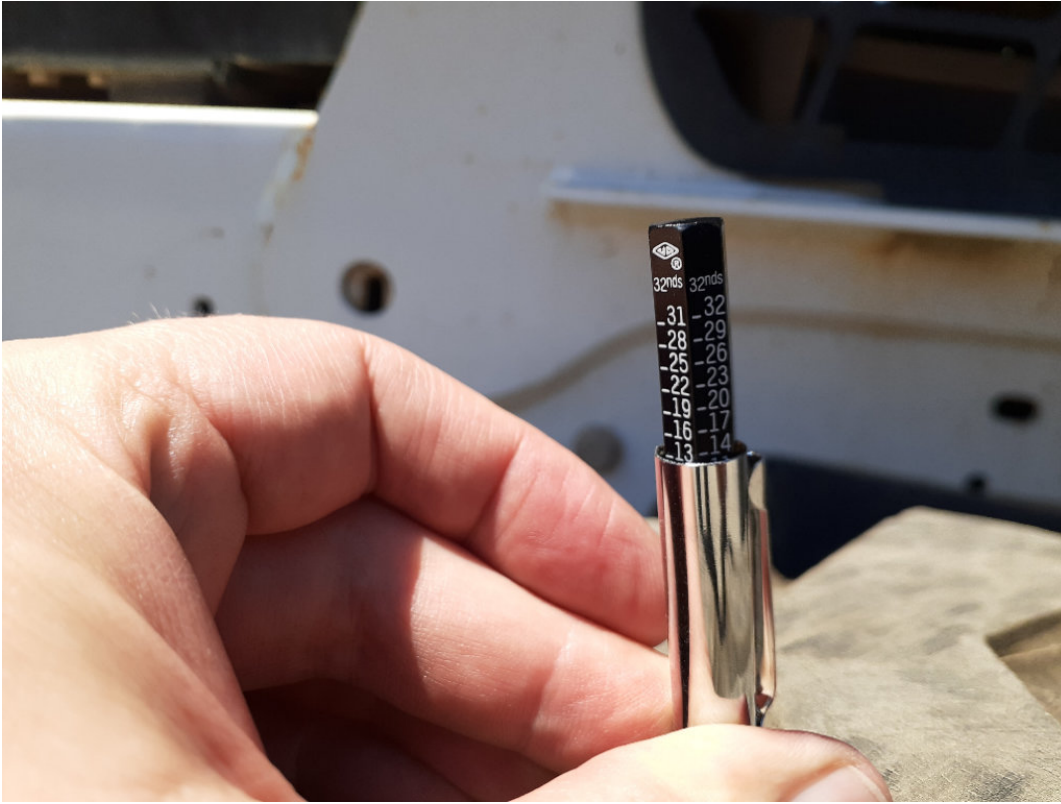
Back Left Tire Tread Depth / Tire/Track Depth / 06-19-2020
